# **42/50G2 PDP modules vertical line issue repair method**

**HE Company / LGERS / Design Gr.**

# I. TV models using G2 PDP panels.

## II. PDP module (G2 models) Vertical Noise type

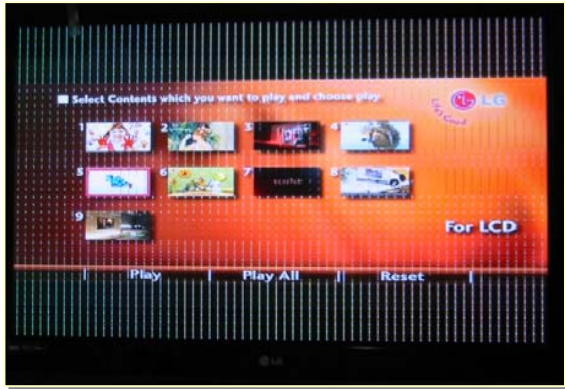
1. Vertical line with same interval (16pixels)

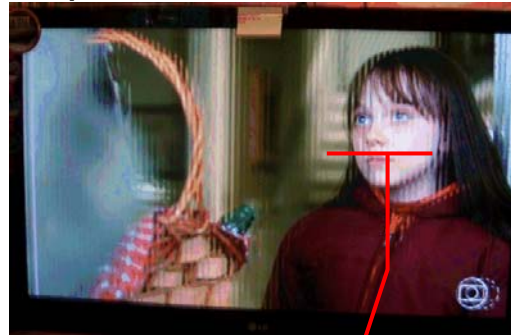
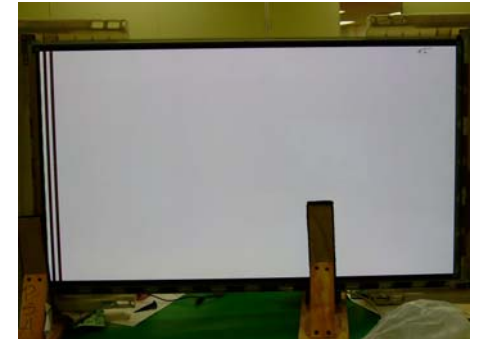
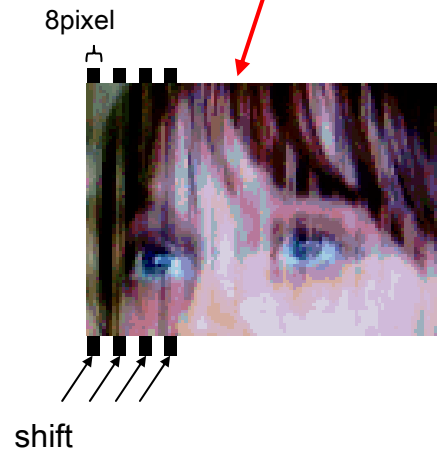
2. Vertical line without same interval (8pixels, 16pixels or 32pixels)

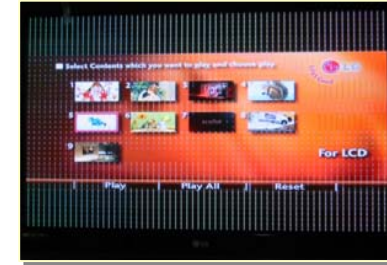
### 1. Vertical line with same interval (16pixels)

This problem is mostly related to failure in DQ signal paths from DDR2 memory IC251 to BGA IC201.

A. Check the components solder quality, foils and via holes integrity.

B. Press BGA IC firmly to check for bad solder.

If everything is OK and failure persist, change the control board assy.

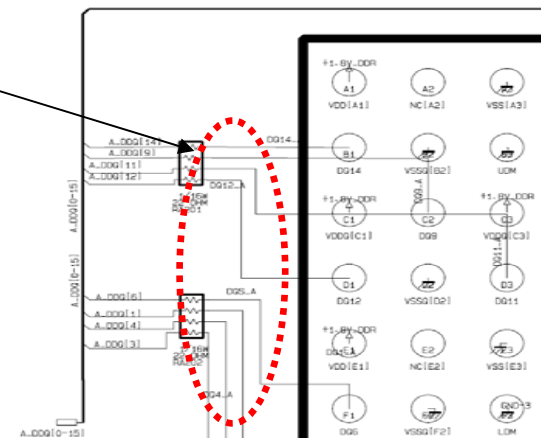
#### Check points

C. Check diode value of the 16 DQ lines using multi-meter, GND(+)-to-DQ line(-) (refer to A3 picture in the last slide)  
Normal diode voltage drop is (0.4 to 0.5 Vdc).

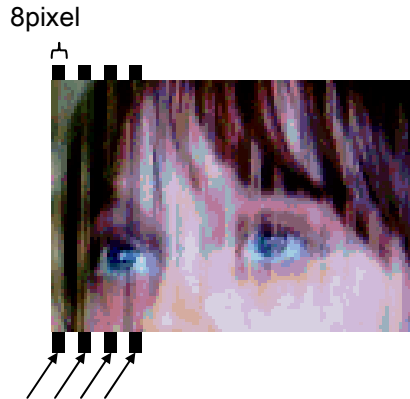
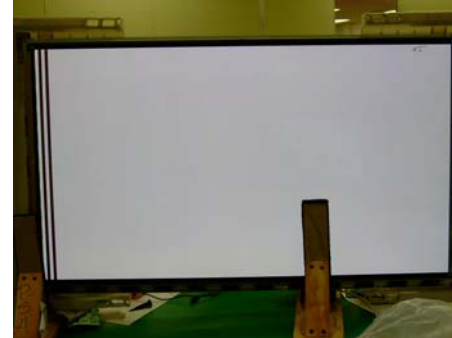
### 2. Vertical line without same interval (8pixels, 16pixels or 32pixels).

-  $1k\Omega$  has some potential probability to cause vertical lane when repeatedly connected and disconnect of LVDS cable.

- A. Check the control board DQS Resistors coming out from DDR memory to BGA IC (backside R282 , R283 , R284 , R285)

- DQS (local clock function) resistor value must be  $470\Omega$ .

If  $1K\Omega$  resistor value is found, change to  $470\Omega$  ( $1k\Omega \rightarrow 470\Omega$ ).

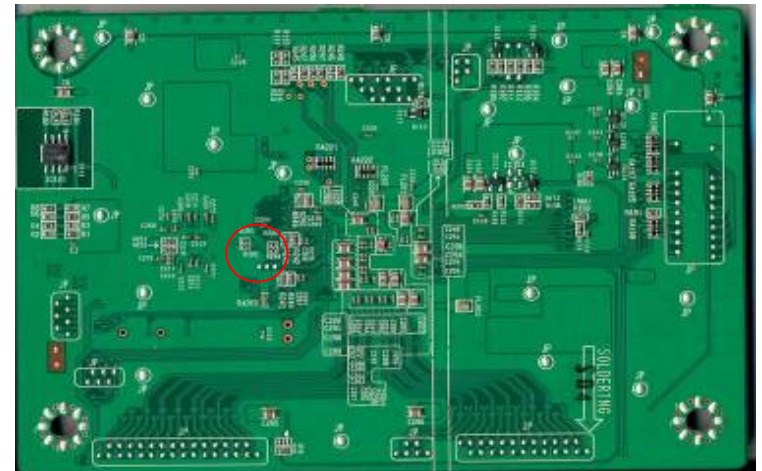
- B. Check diode value of the 4 DQS lines.  
(refer to A3 picture in the last slide).  
Normal diode voltage drop is (0.4 to 0.5 Vdc).

If everything is OK and failure persist, change the control board assy.

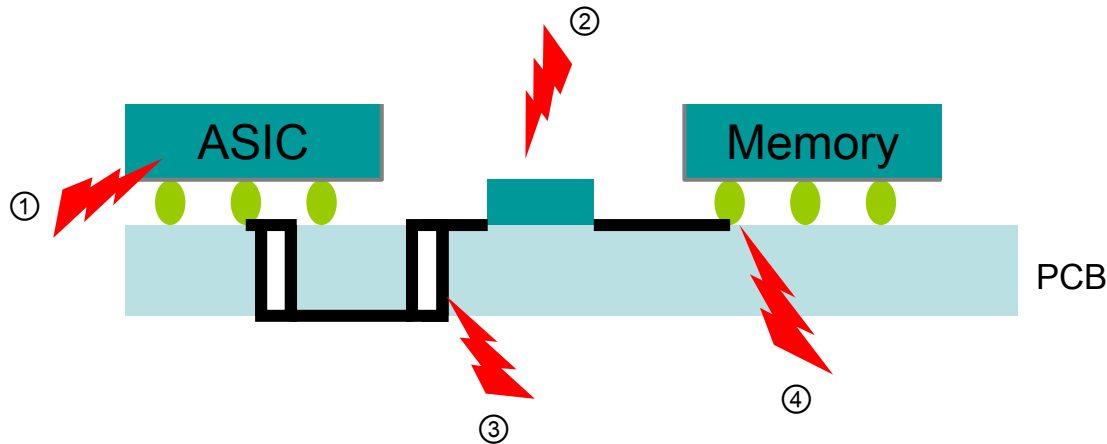
# A1. Vertical Noise Failure cause

## Possible Failure Cause of Picture (Vertical) Noise upon DDR Memory

- ① Pin fail : Diode check with multi-meter.
- ② Resistor Crack and soldering problem : visual inspection
- ③ Via hole crack : Diode check, resistor check visually and using multi-meter.
- ④ Ball crack and soldering problem in BGA IC's: Press devices toward PCB

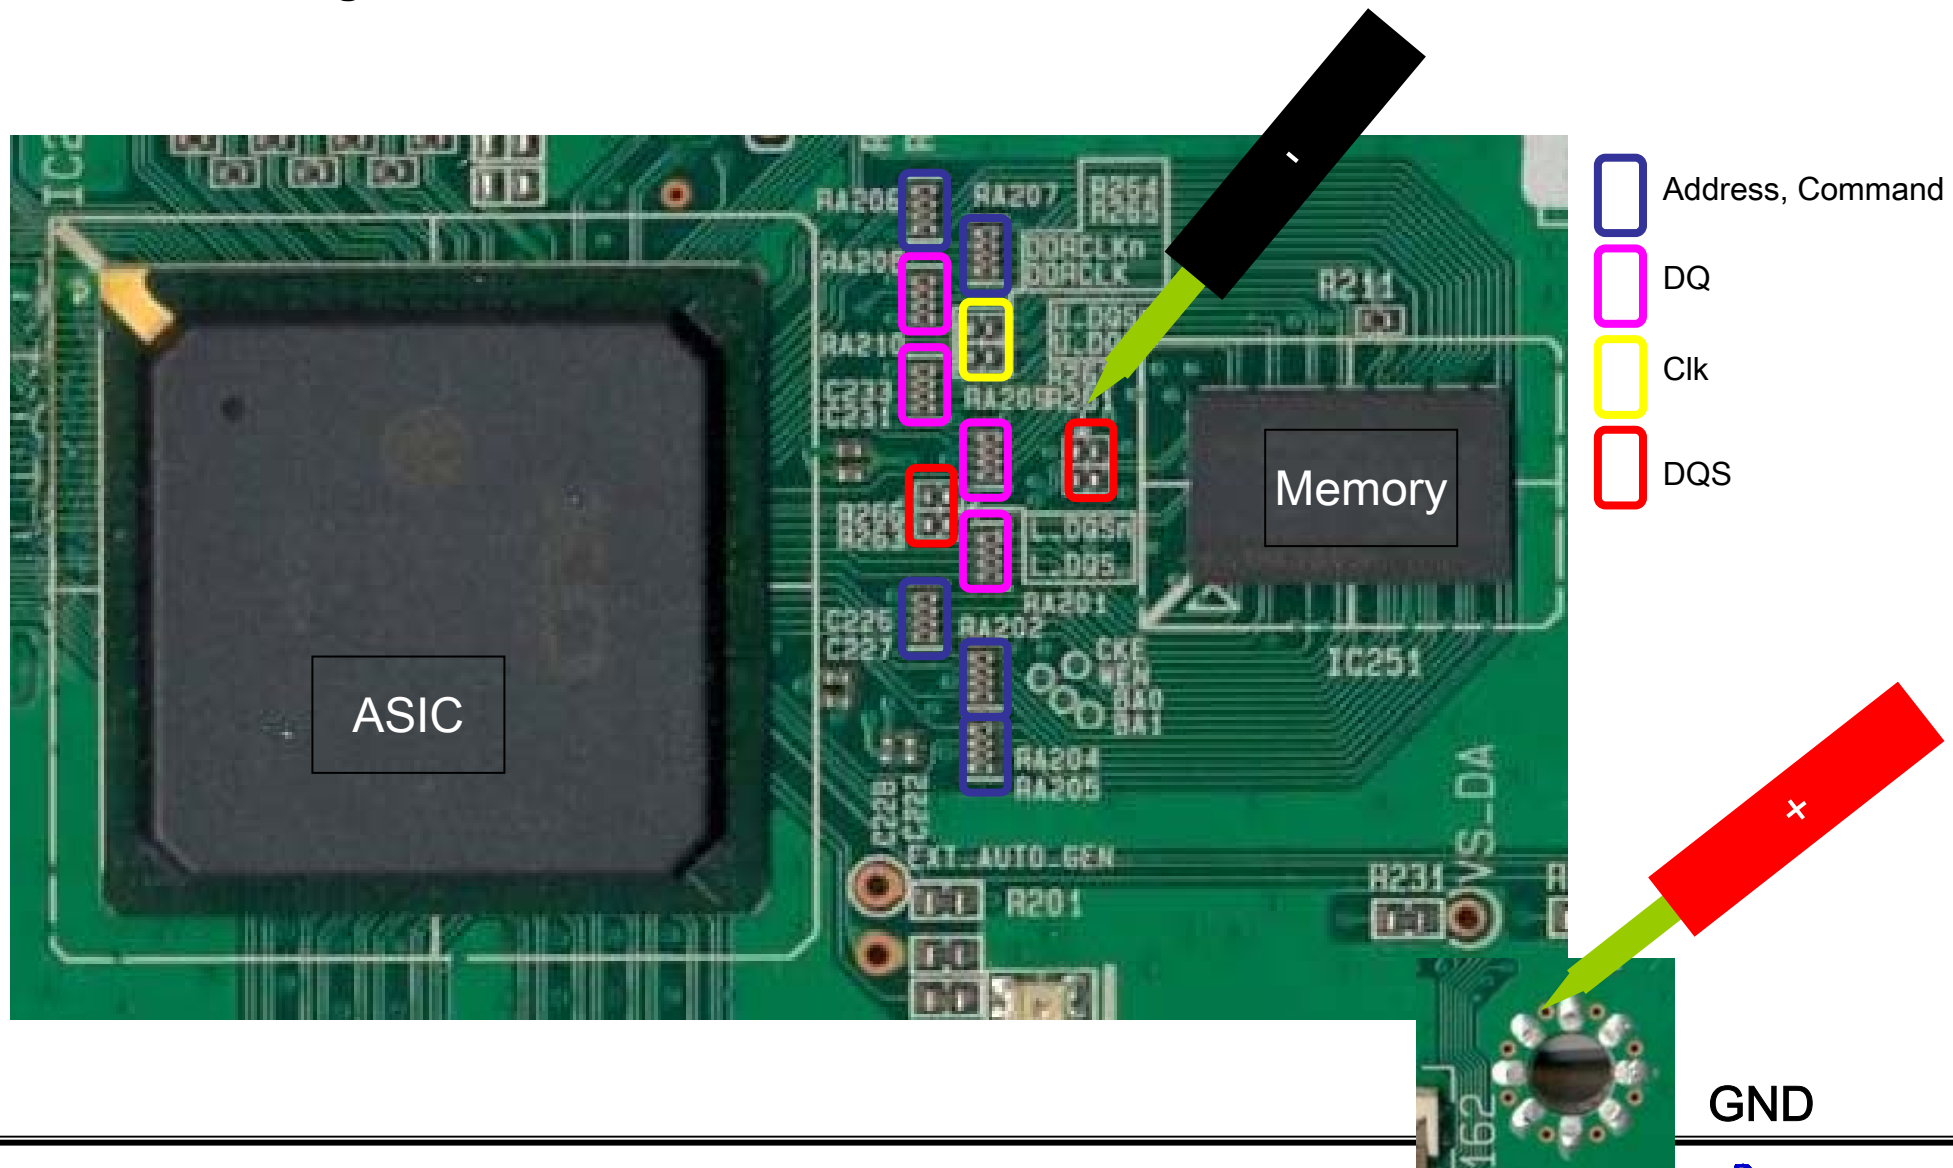
### A3. Measuring Diode value of DQ and DQS

### ✓ Diode check using Multi-meter
